Manhole Inspection Summary

Manhole # S05CC1005MH

Location Address: **3836 SEQUOIA AVE**

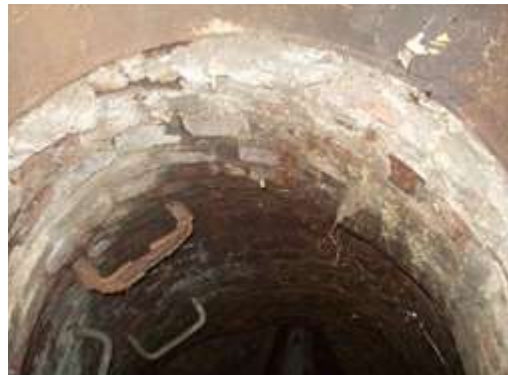
Defect 2

Condition: ☐ Sound ☒ **Cracked** ☐ Root Intrusion ☐ Loose Brick ☐ Deteriorated

LOOSE BRICKS CORBEL

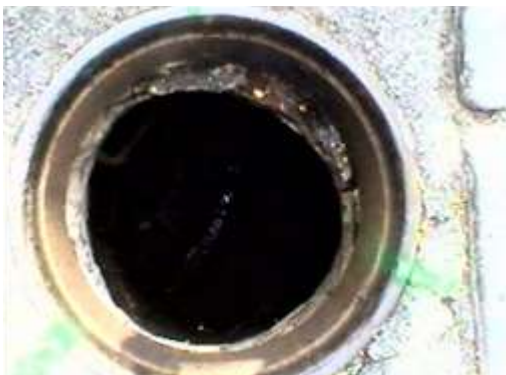
Defect 3

Offset: **3** (in.)

OFFSET FRAME

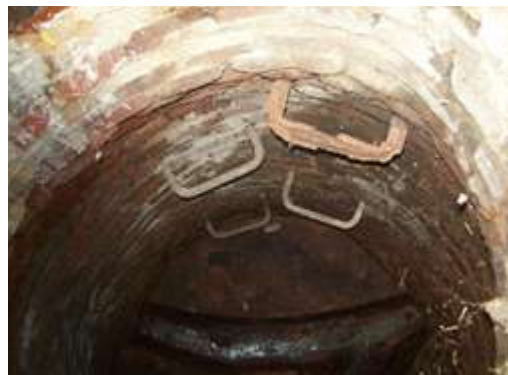
Defect 1

Count: **4** Missing: **0** ☒ **Corroded**

CORRODED STEPS

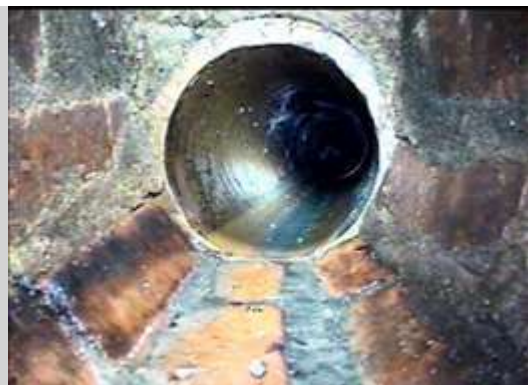
7 O'Clock Inflow

6 in. Circular Gravity Sewer
Pipe In @ 7 O'Clock

Pipe Seal Cond: **Cracked**
